**STEADFAST**  
HOME INSPECTION

# HOME INSPECTION REPORT

**123 Somewhere Street**  
**Somewhere, CA 93000**

Prepared for:  
Jack & Jill Homebuyer

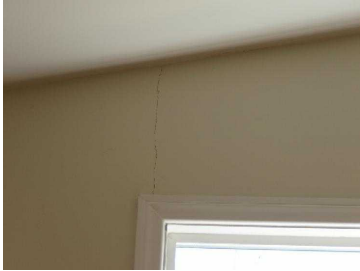
- 1. Marginal **Walls:** Drywall / sheetrock - *A few small cracks were found, but they appear to be typical and not indicative of a larger problem.*

1. Master Bedroom Bedroom Walls: Drywall / sheetrock - [A few small cracks were found, but they appear to be typical and not indicative of a larger problem.](#)

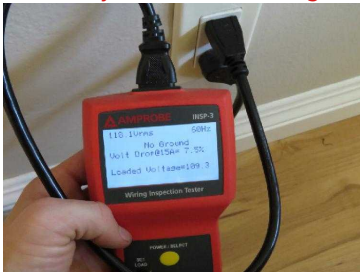
- 2. Acceptable **Ceiling:** Drywall / sheetrock
- 3. Acceptable **Floor:** Carpet
- 4. Acceptable **Doors:** Hollow wood
- 5. Acceptable **Windows:** Aluminum slider, Dual paned
- 6. Health/Safety **Electrical:** 120VAC - *Open grounds noted at 3-pronged outlets. This represents a safety hazard and may result in damage to equipment. Recommend further evaluation by a qualified electrician.*

1. **Master Bedroom Bedroom Electrical:** 120VAC - Open grounds noted at 3-pronged outlets. This represents a safety hazard and may result in damage to equipment. Recommend further evaluation by a qualified electrician.

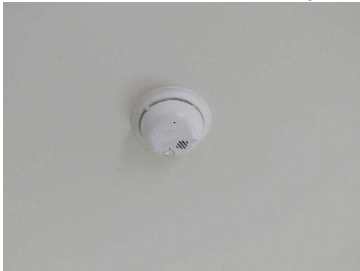
- 7. Acceptable **Closet:** Single, Sliding doors
- 8. Acceptable **HVAC Source:** Heating system register
- 9. Acceptable **Smoke Detector:** Battery-operated

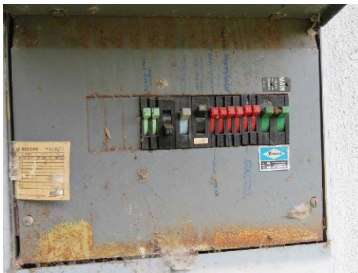
11. Health/Safety Manufacturer: Zinsco - The panel is a Zinsco brand panel, which is well documented to have a high rate of failure and is a fire hazard. Further evaluation by a qualified electrician is recommended. For more information on these panels, type "Zinsco panel" into any search engine.

2. **Exterior Wall Electric Panel Manufacturer:** Zinsco - The panel is a Zinsco brand panel, which is well documented to have a high rate of failure and is a fire hazard. Further evaluation by a qualified electrician is recommended. For more information on these panels, type "Zinsco panel" into any search engine.
